Our Ref: 22014/FW

22014 – Updated inspection of the Old Social Work Building, Nairn

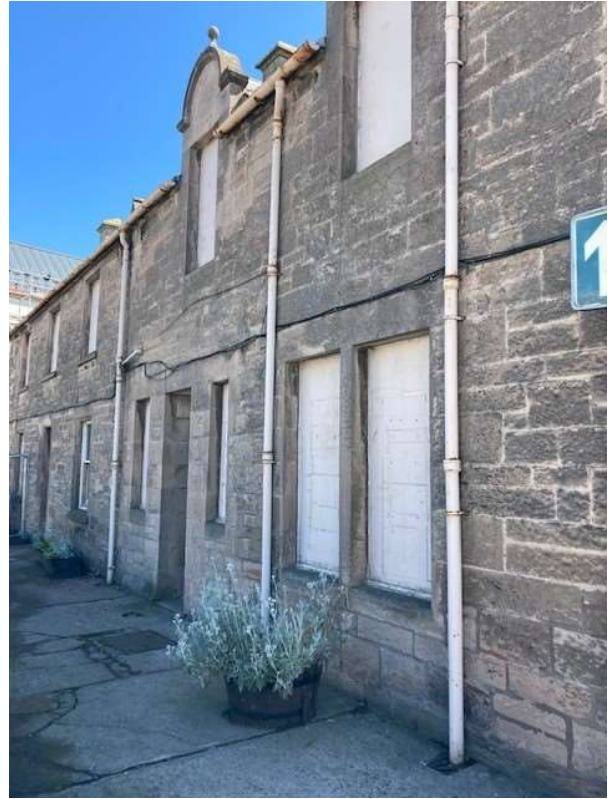
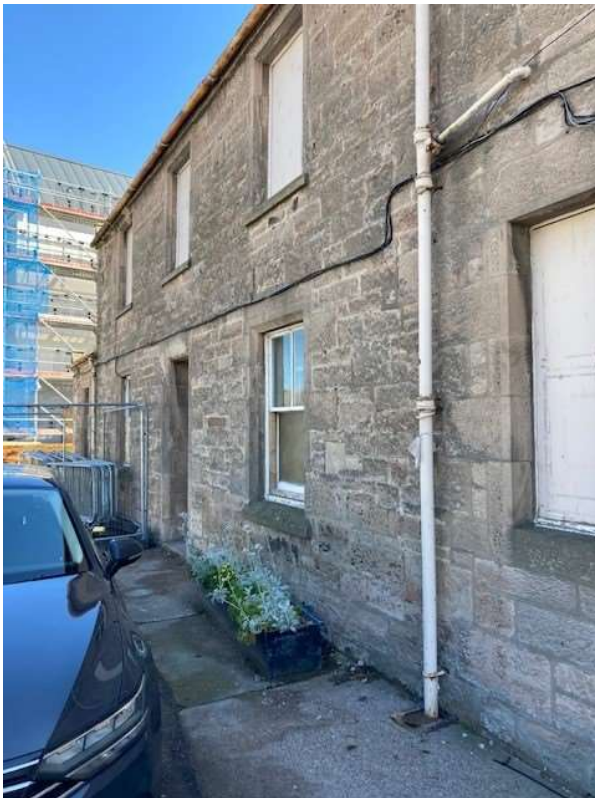
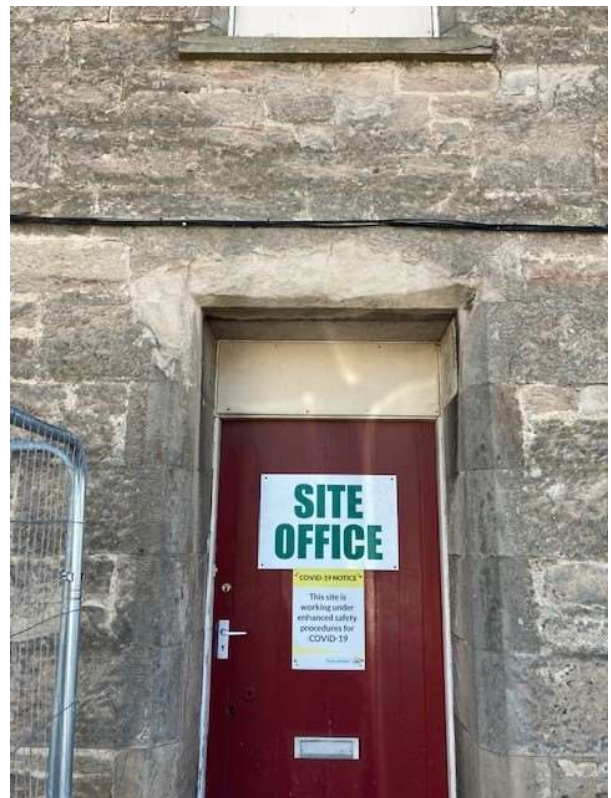
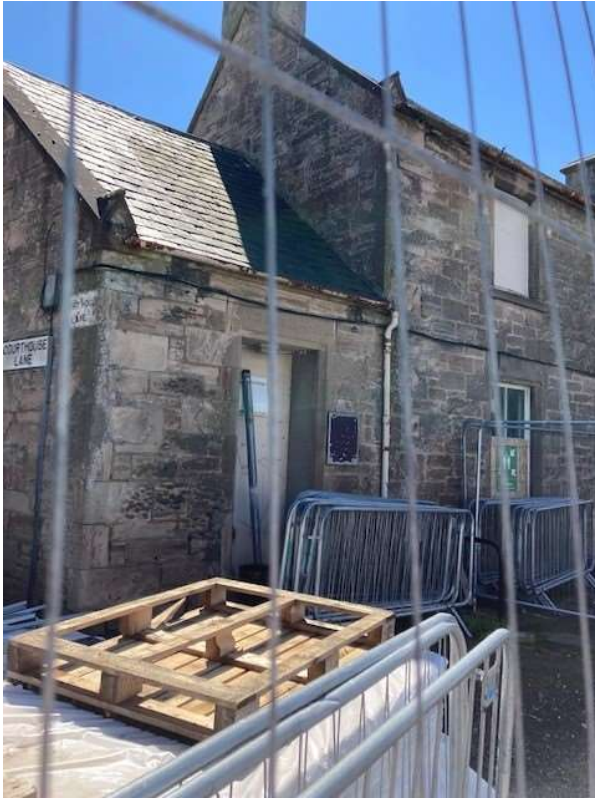
The stone to this elevation remains in reasonable condition and although it has possibly slightly deteriorated there are no further significant defects other than those previously noted – some delamination, slight erosion of the stone face and some mortar loss in places. To the left hand end the gutter has been cleared, which appears to have prevented further significant deterioration of the stone, as previously highlighted in that area. Photos 6-9 show the general condition of the elevation.

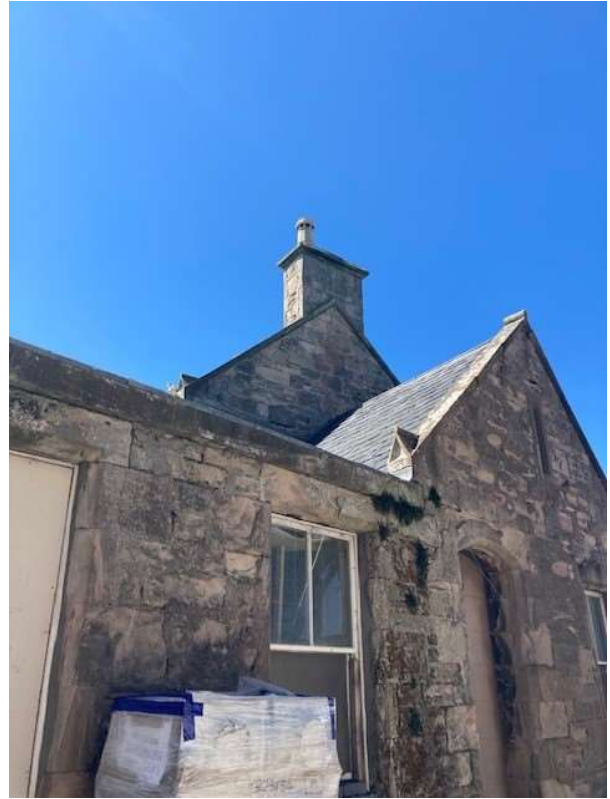
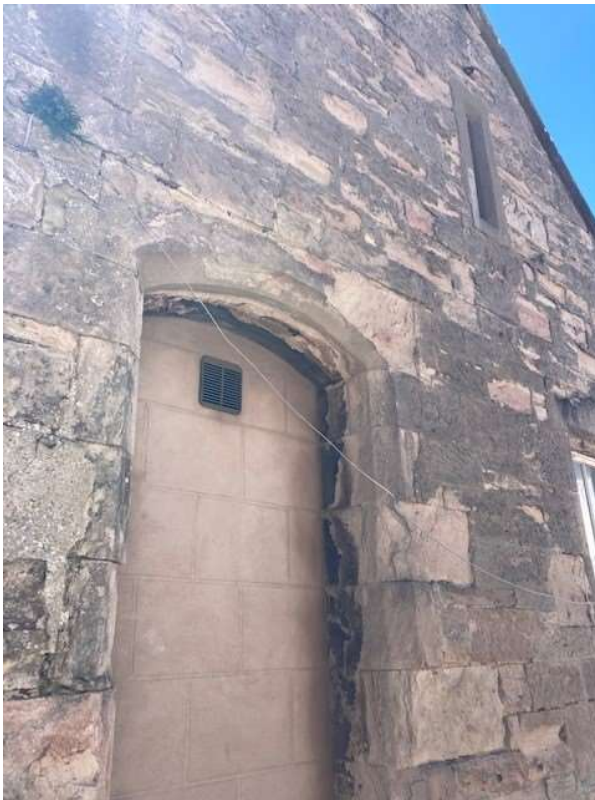
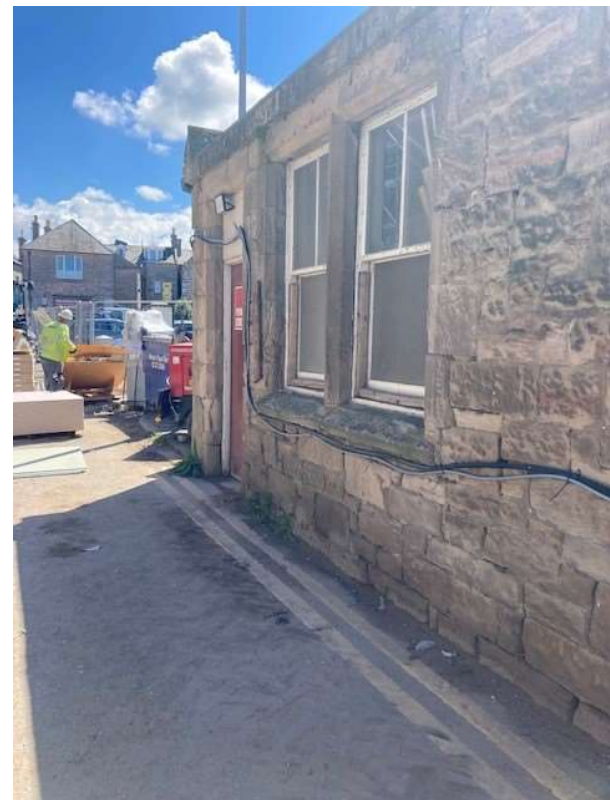
The condition of this elevation appears to have significantly deteriorated in places, since the previous inspection. The joints to the lower courses, over the majority of the wall, are very open and a lot of the stone is delaminated or has suffered from erosion to the face. Photos 10-12 show the general condition. Photo 13 shows the erosion of the stone local to the rear door. Photo 14 shows the vegetation growing out of the mortar joints and the open joint above the top of the adjacent window, which appears to have led to water ingress and the collapse of the internal finishes local to the window. This is likely to have caused some deterioration of the timber safe lintels behind the finishes.

The condition of the stone, particularly to the chimneys and the wall areas highlighted on Falconer Lane and parts of Courthouse Lane, needs to be addressed to ensure they do not deteriorate further. An experienced stone mason will be required to assess which stone can be saved and which will need replaced. The condition of the stone to the courtyard area should also be checked as part of this in case there are areas requiring urgent attention.

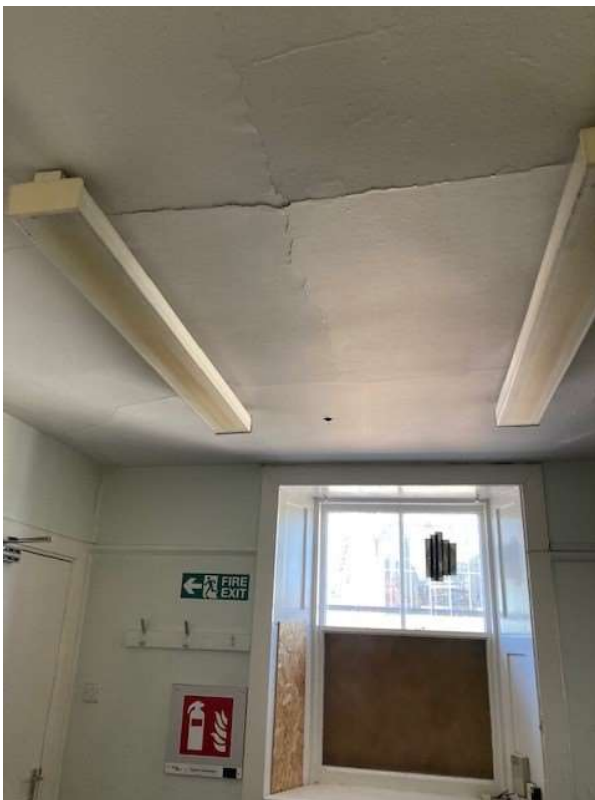
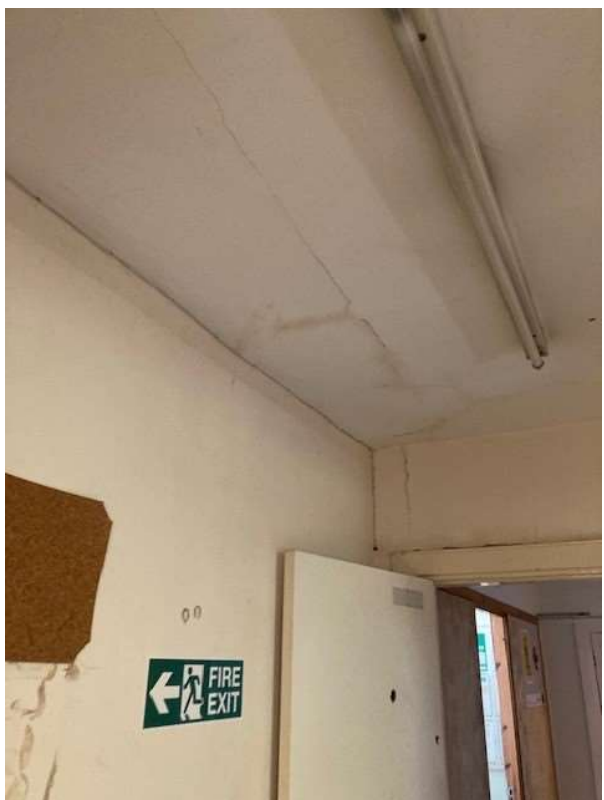
The condition of No 60, when compared to the photos previously supplied, appears fairly similar in terms of condition, apart from what appears to be general wear and tear and with the exception of the area of water ingress and damage to the finishes on the window on Courthouse Lane, previously mentioned. Many of the plaster ceilings and walls are cracked, which again is to be expected given the age of building. The ceiling to the front left hand room appears to be in particularly poor condition, with cracks running across in both directions and the ceiling to the hall to the rear of this room appears to have suffered water ingress and subsequent cracking but no comparison photos are available to check if this has deteriorated since 2013 or is possibly due to the storage in the room above, in the case of the front room. Given the extent of the cracking to the front room this could lead to spalling of the plaster, so should be monitored and ideally removed or repaired to avoid a risk to the building users. Photos 15 & 16 show these ceilings.

The cracking to the internal rear wall of No 60, mentioned in the original report, should be addressed during any redevelopment work, with the crack being stitched as required. The ceilings to the rooms noted should be monitored and if not immediately repaired, then replaced during any future works.
